## A HISTORIC STRUCTURE REPORT

# THE GEORGE NAKASHIMA FAMILY HOUSE

## Historic Structure Report

December 16, 2024

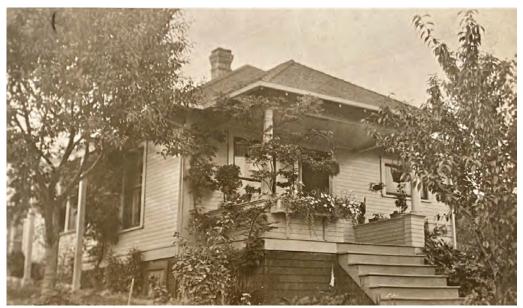
The "first" Nakashima family home. Located at 3808 South Genesee St., Seattle, the house stands on a corner lot with southern and western orientation. Note the pergola attachment on the west side to provide sun control and the lovely collection of plants on the porch. Photo, c. 1935, presumably taken around the time the family sold the house and moved to Portland, Oregon. (Michener Museum Archives; box 12, folder 26)

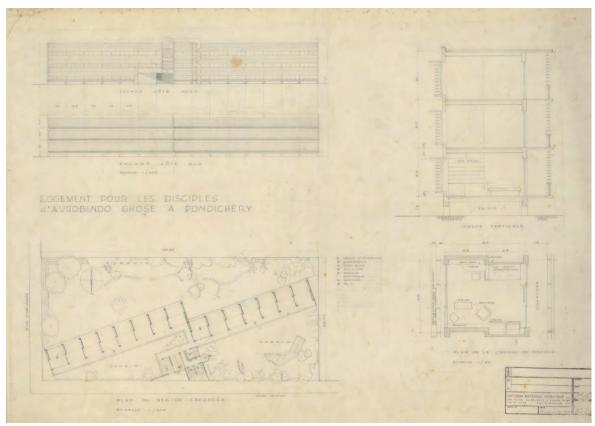
Dormitory for Sri Aurobindo, initial design, dated Oct. 12, 1935, George Nakashima, delineator (RKSJ, Tokyo)

The Golconde Dormitory (1935-45) was projected as a concrete structure facing north and south. Essentially, it was comprised of two rectangular volumes, offset to each other, joined and served by a central functional tower containing the stairs and the hygienic facilities. Modest rooms dedicated to sleep and study were placed on the upper levels, whereas the dining and common rooms were located at the ground level. The building was engineered to adapt to tropical and humid climatic characteristics. A roof of precast concrete barrel shells (for Nakashima – a precursor to the precast roof system that he deployed for the Family House), louvered walls, and cantilevered overhangs provided shielding from the sun and heat control.

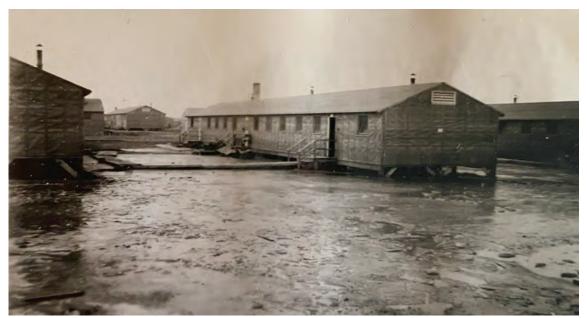
View from the Nakashima's photo album, presumably this shows "Building 34-3F" (Nakashima Foundation Archives, KHPA\_049).

Barrack buildings were identically built and measured 120 by 16 feet. Interiors were divided into four or six tiny "apartments," with a 20 by 16-foot room housing a family of two or more (or three or more single people).

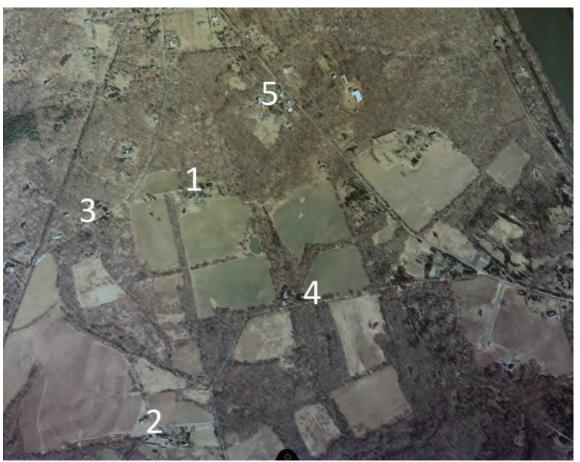
Aerial view, taken in 1979, showing the vicinity of "Sycamore Farm" (labeled #1) and the relative locations to the Nimicks' property of the parcels transferred to: Antonin and Noémi Raymond (labeled #2, property located on Pidcock Creek Rd.); Robert Hogue (labeled #3, property located on Old Windy Bush Rd.); Harry Rosin (labeled #4; property located on Covered Bridge Rd.), and George and Marion Nakashima (labeled #5, on Aquetong Rd.). (Nakashima Foundation Archives)

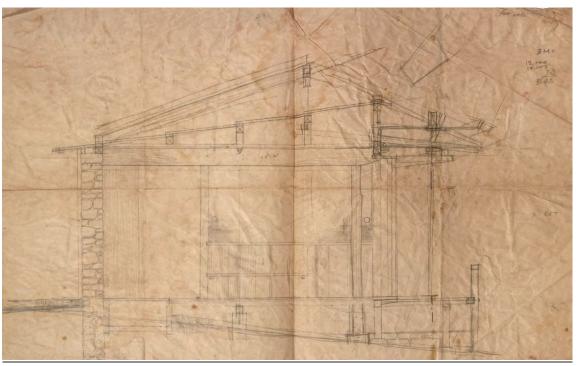
Section study, c. 1946. Note: Nakashima sketched early ideas for 1982 alterations on top of the earlier drawing. [Michener Museum Archives]

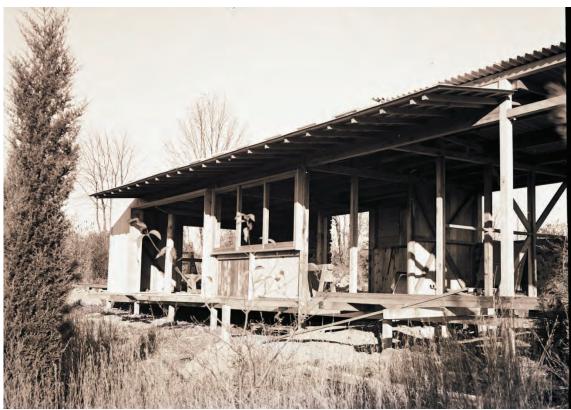
Nakashima House, construction in fall 1947 (Nakashima Foundation Archives]

With winter fast approaching – and the need for the family to move out of the tent and into a heated space – Nakashima, with the full-time assistance of Hight (and 1-2 days per week from Naylor), focused his "entire time" to completing the enclosure of the house, along with the kitchen and bathing facilities. <sup>116</sup> Navy surplus "3/8 inch pressured pure asbestos" panels were used to sheath the house. Roofing materials shifted from his pre-cast system to mass-produced corrugated Transite panels, most likely in an effort to expedite protection of that portion of the house's framing before the onset of winter; a temporary solution that, more or less, became a "permanent" condition.

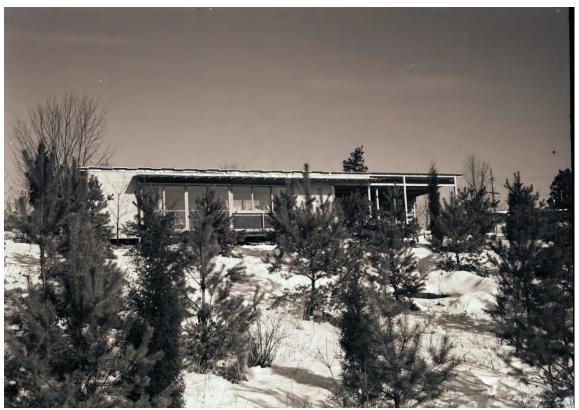
In January 1948, George took a moment to photograph the house after a snow fall. <sup>120</sup> These photos show the unfinished eastern portion of the house. Of this time living in an unfinished house during winter was remembered by George as, "bitterly cold," so much so that the faucet in the kitchen froze. <sup>121</sup>

House in January 1948 in a photo taken by George Nakashima (Nakashima Foundation Archives).

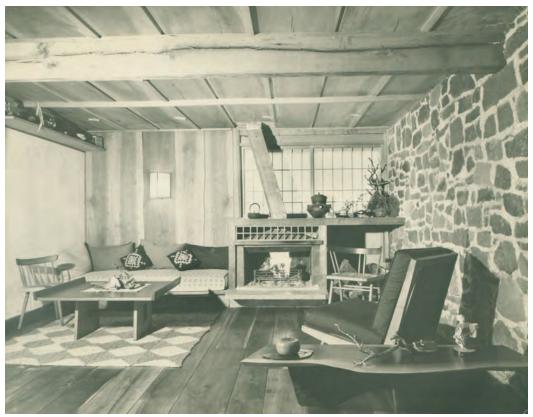
View of the living room with Bitterbrush incorporated as table displays, above the fireplace and, as Nakashima had done in the "Model Apartment" at Minidoka, as a fixed shelf support (visible at the upper left of the photo). Photo by Hal Kelly, dated c. early 1949. (Nakashima Foundation Archives)

By October the family could move into the bedrooms and at Christmas time, they enjoyed eating baked potatoes and steaks cooked on the newly finished living room fireplace. <sup>124</sup> Nakashima's father sent a special shipment of Bitterbrush (that had been collected by George and Kenny Hikogawa in the Idaho desert) with the suggestion that, "...I think you could use them for your works." <sup>125</sup> At first, Nakashima simply staged pieces in important locations within the house (like the mantle above the fireplace or on top of the Milk House table), and later, used the wood for handles throughout the house, the most prominent of which is the cabinet adjacent to the fireplace.

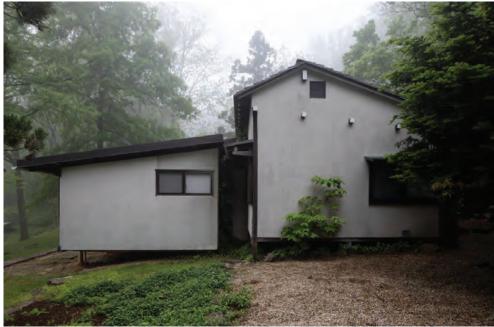
Nakashima House, summer 2020 (Elizabeth Felicella)

At age 77, Nakashima undertook alterations to the family house. Leaks in the original roofing – as well as a desire to make the house more energy efficient – led him to reconfigure the roof (providing ample room for insulation), and to extend the interior by about three feet by incorporating the deck into the interior of the house. <sup>147</sup> New windows and a large Pella patio door were installed; a "moon-viewing platform" provided for outdoor seating. <sup>148</sup> Modifications were also made in the living room where the built-in seating was removed and replaced with cabinetry. The original paneling was relocated and incorporated into the kitchen cabinetry and the door to the bed rooms. Drive-it was applied to the house exteriors.

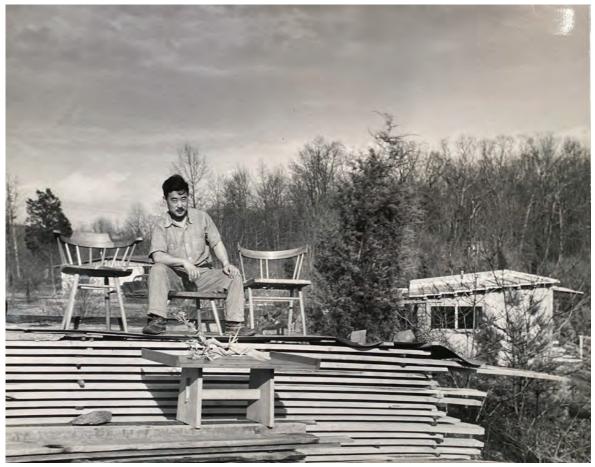
George Nakashima and his "world", c. April 1948. (photo by John Corcoran for Science Illustrated, Michener Art Museum Archives)

The Family House (at right), while inhabited at this time, remains in an incomplete state. Nakashima, seated on a Plank Stool, is flanked by two chairs of his design. In the foreground is his "Milk House Table" and upon that is a piece of "Bitterbrush" that he gathered during his incarceration during World War II. This composition of woodworker and his work occurs atop of a pile of wood planks, left out in a yard space to dry. Visible behind Nakashima is the Workshop (the first building erected on site), and his car, a connection with the outside world.

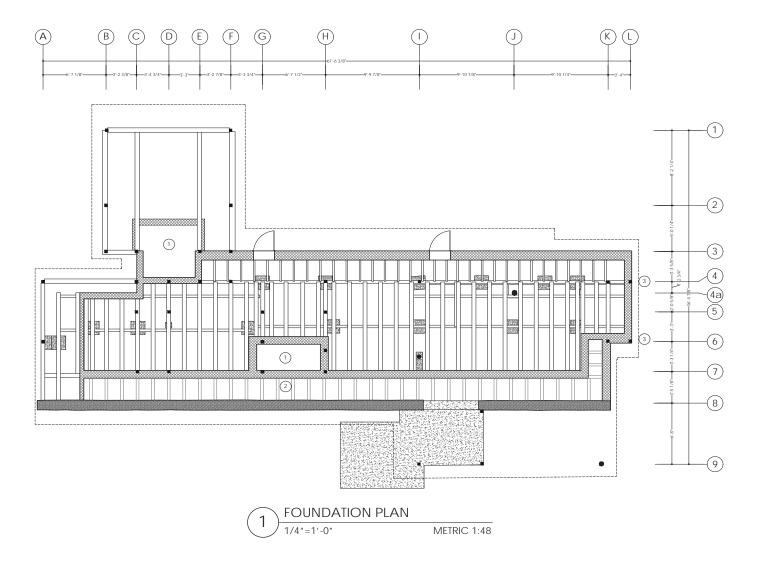
- 1. Concrete Block Chamber: Two C.B.C.s are present, one located beneath the bathroom and the other under Kevin's bedroom. These chambers serve multiple
- purposes, including providing a foundation for the structures and bracing above, as well as housing utilities such as plumbing and pipes.

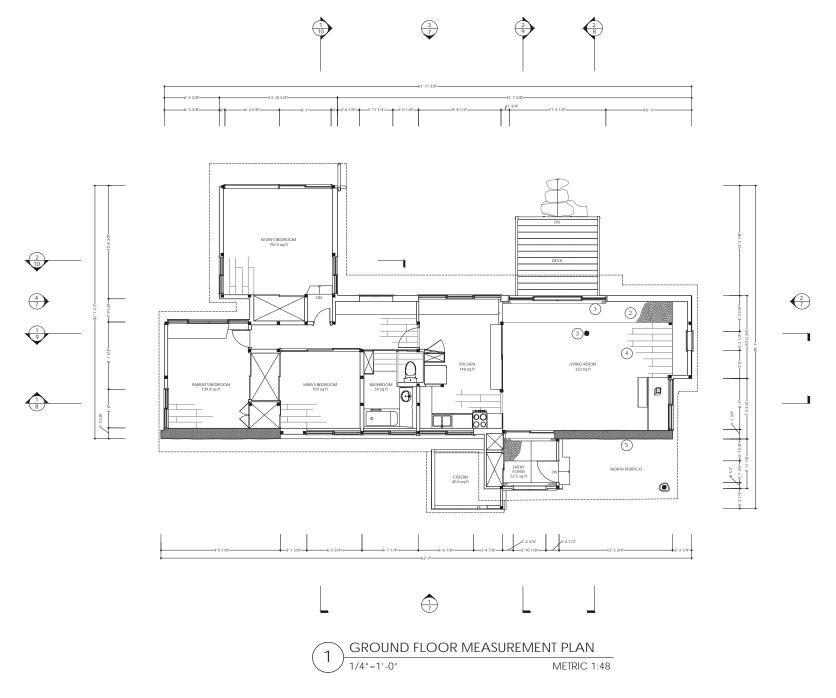
- 1. Rubble Stone Strip: Decorative strips of rubble stones embedded in concrete are featured in the living room and entry space.
  2. Concrete Floor Finish: Used as the finishing material for the entry space and the area adjacent to the southern sliding door in the living room. This concrete-floored area in the living

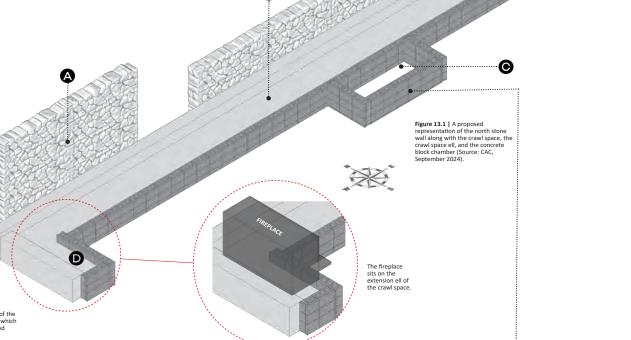
The east-west wall of the concrete chamber below the bathroom contains an opening currently concealed by Styrofoam (or material). Originally, this opening likely held a screen for su ventilation and was covered with a solid panel in winter m to retain heat (Source: CAC, June 2024).

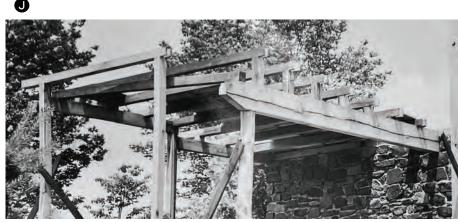
Figure 15.5 | A view looking west showing the small intermediate struts placed on top of the transverse girts ensuring the necessary slope for the roof purlins. Open mortises are visible and ready for connection to extend the purlins using tenon joinery, ca. August 1947 (Source: Nakashima Foundation for Peace).

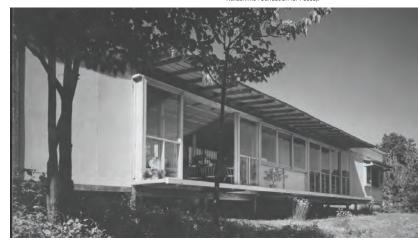
Figure 16.8 | A photograph taken after the construction shows how the original veranda dominated the south elevation, June 1949 (Source: Nakashima Foundation for Peace).

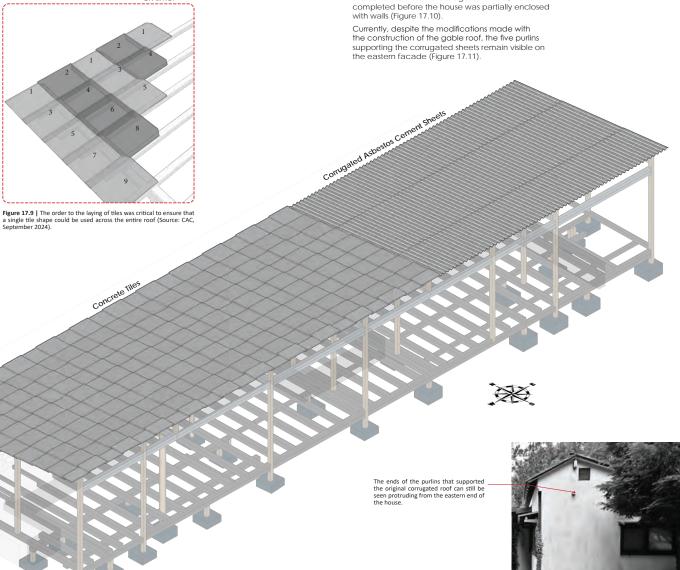
Figure 17.11 | East elevation of the Nakashima house with visible purlin supporting the original roof (Source: CAC, June 2024).

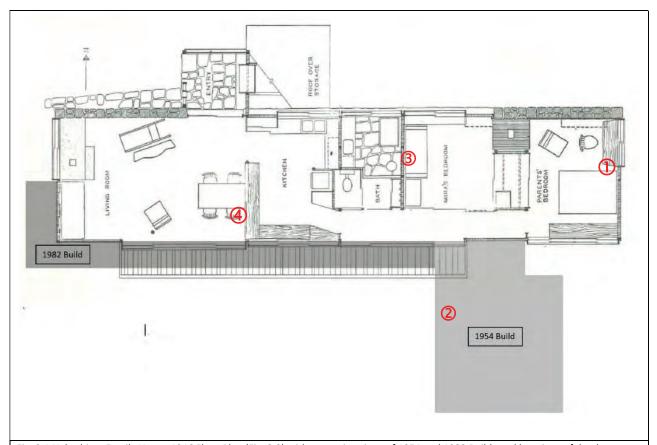
Fig. 2.1 Nakashima Family House 1946 Floor Plan (Fig. 2.2) with approximations of 1954 and 1982 Builds and locations of dataloggers Credit: Michael C. Henry

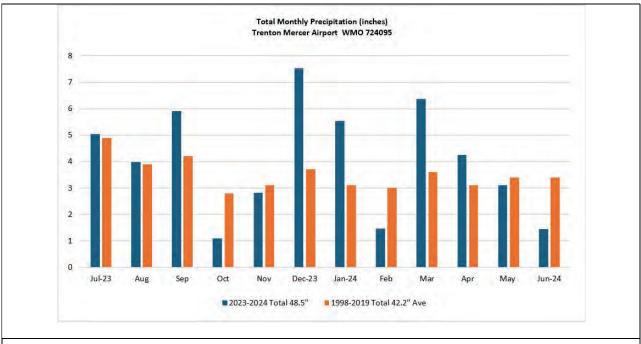
Fig. 2.6 Nakashima House Environment: Precipitation 07/01/23 to 07/01/24 and 07/1998 to 07/2019

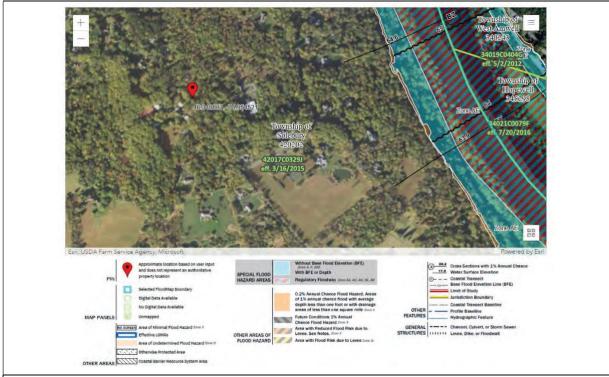
Fig. 2.33 FEMA Flood Map for area surrounding *Nakashima Woodworker Complex* Image Credit: <a href="https://msc.fema.gov/">https://msc.fema.gov/</a>

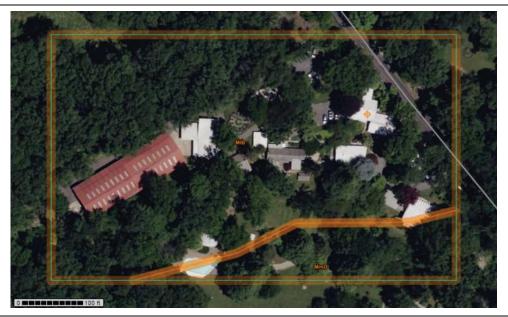
Fig. 2.34 Site Soils at The Nakashima Family House site

The Natural Resources Conservation Service (NRCS) of the U.S. Department of Agriculture provides a broad assessment of the soils at the Nakashima Family House. *Mount Lucas Silt Loam 3 to 8% slope (MIB)* is the major soil surrounding the house and garage (Figure 2.34). The slope south of the House is identified as *Mount Lucas Silt Loam, 8 to 25 percent slopes, Extremely Stony (MmD)*.
